## WEEKLY STATUS REPORT

BCP Project No.:	C224099	EPA Consent Order No.:	CERCLA-02-2017-2021	Date:	09/20/2019
Project Name:	BRT Powerhouse 153 2 <sup>nd</sup> Street AKA 322 3 <sup>rd</sup> Avenue, Brooklyn, NY 11215				
Remediation Activities (Week of September 16, 2019): <ul style="list-style-type: none"><li>Continued gauging and product recovery via absorbent sock as necessary.</li><li>Brookside Environmental and Clean Harbors (Site remediation contractors) continued the boiler house lateral discharge tunnel sludge removal in general accordance with the USEPA Building Materials PCB Cleanup Plan submitted to the USEPA on April 9, 2019. Brookside Environmental and Clean Harbors expanded the access holes at the east tunnel, removed large debris (concrete, brick, wood, etc.) by hand and loaded the debris into drums, pumped oily water from the tunnel into the frac tank onsite, and used a Cusco guzzler truck to vacuum the rest of the material (sludge, soil, smaller debris, etc.) out of the tunnel. Fourteen (14) drums of hazardous PCB material were generated by the sludge removal work this week.</li><li>Brookside Environmental poured the three (3) concrete plugs at the ends of the east

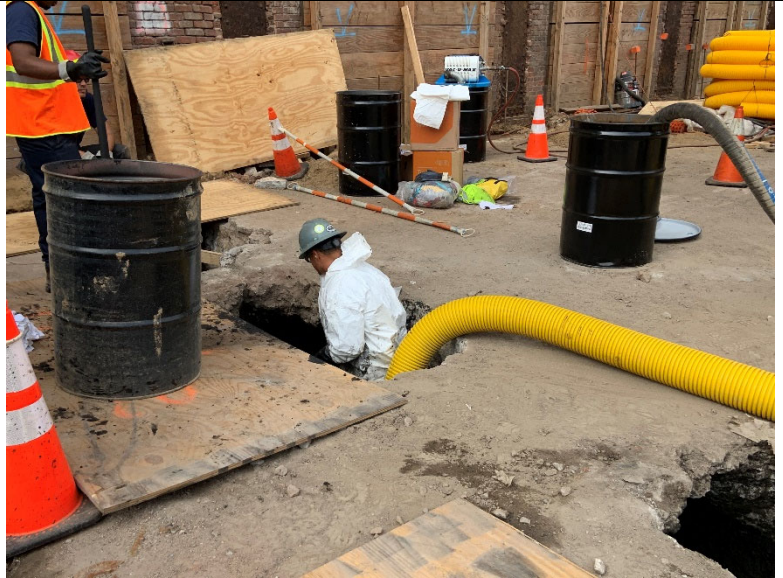
Photo 1 – Looking north at the east boiler house lateral discharge tunnel. Clean Harbors uses the Cusco guzzler to remove sludge and other material from the tunnel.

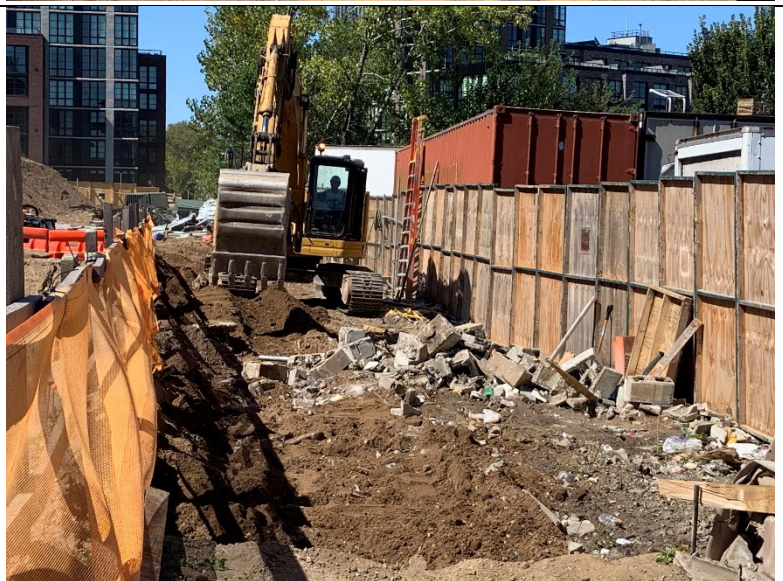
Photo 2 – Looking west at north property line. Structure Tech excavates approximately 2 ft of soil to prepare the area for SOE installation.

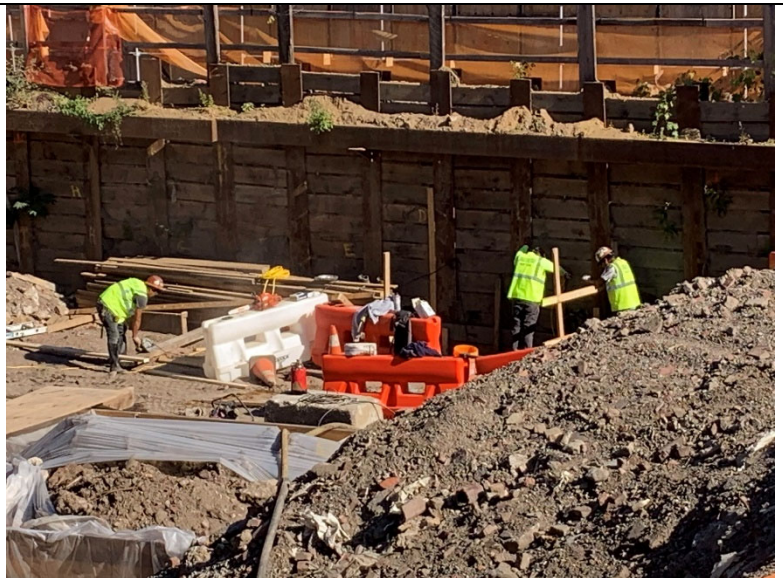
Photo 3 – Looking north at the northeast boiler house slab test pit. Structure Tech and Langan expose and inspect the piles under the boiler house slab.
